## MEMORANDUM

**HSM-11011**

SUBJECT: OBSERVATIONS OF A FUMIGATION/AERATION ADJOINING MY HOME

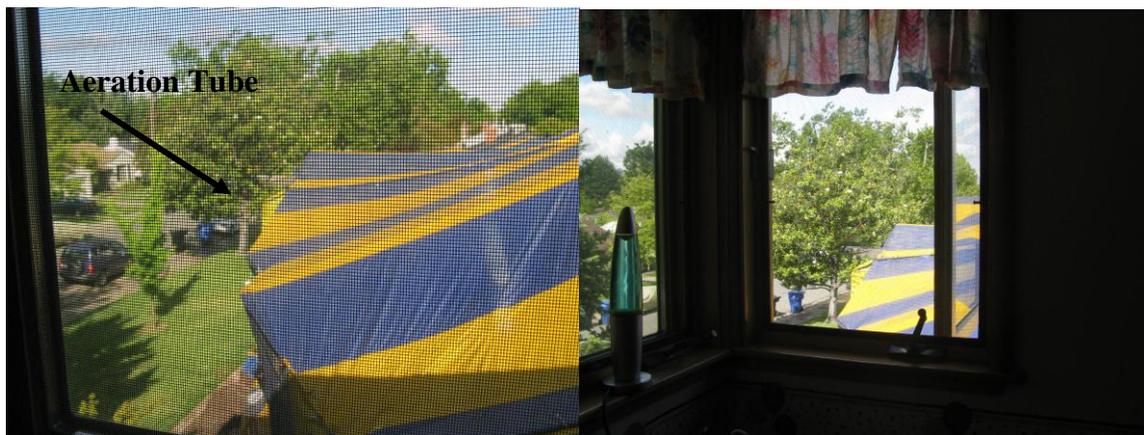
Photo Set One: View from bathroom window

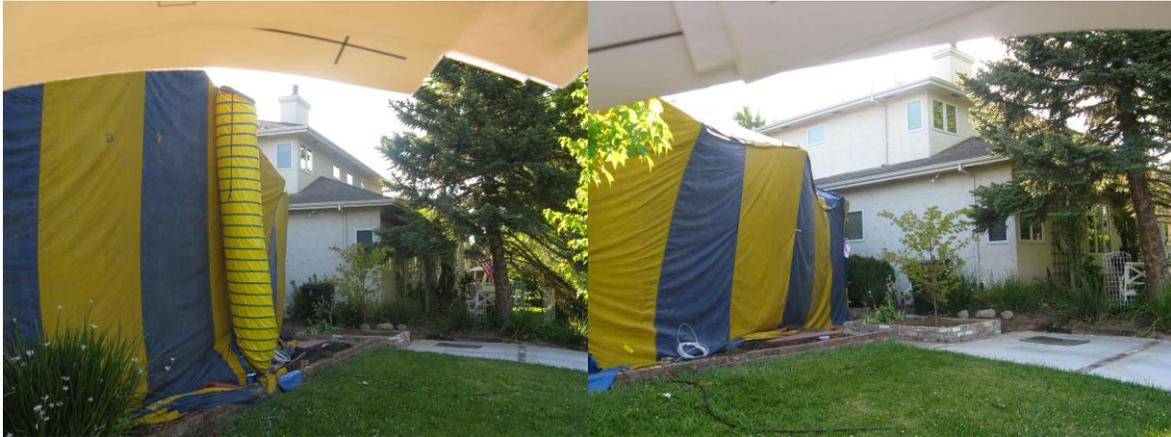
Photo Set Two shows the reverse angle of the same location. These photos show that the aeration tube exit was in relatively close proximity to the bathroom windows and at essentially the same elevation. This situation suggested a potential opportunity to monitor sulfuryl fluoride infiltration during aeration.

Photo Set Two: View of fumigation, aeration tube and window from ground.

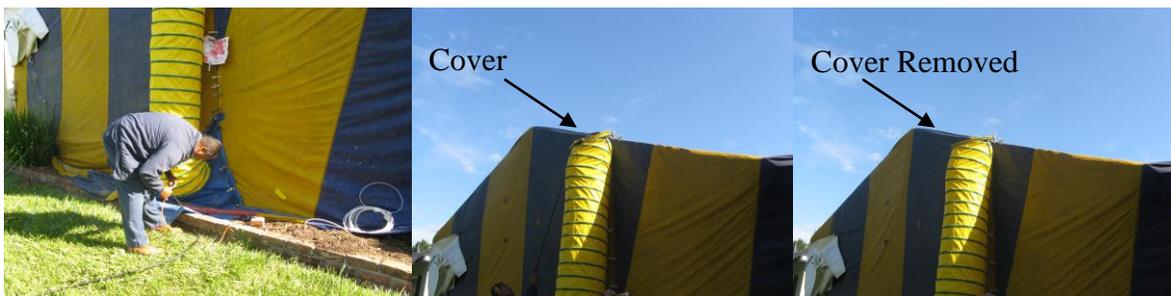
Photo Set Three: Fan Activation/Cover removal/Air flow

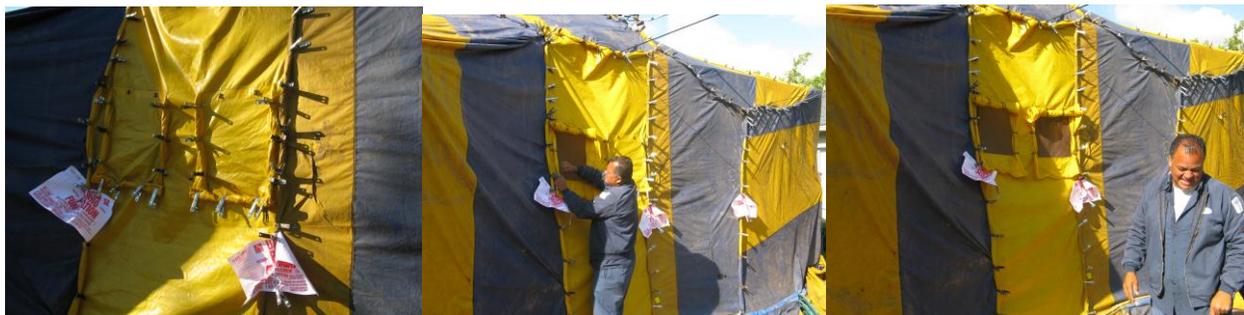
Photo Set Four: Opening aeration air intakes
