Figure 1. Study site photos

Figure 2. Field schematic. Not drawn to scale, ditch size exaggerated to show detail

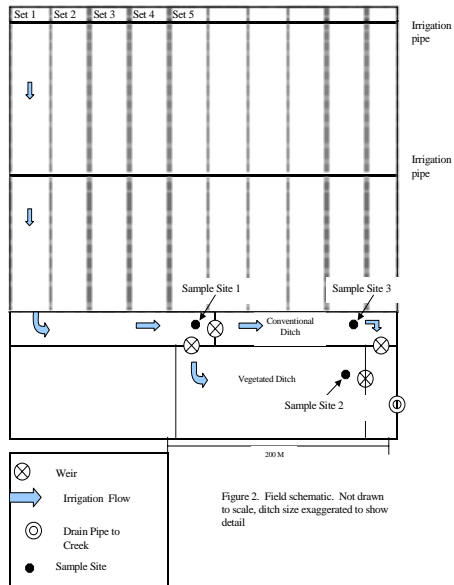
Photo A. Flood Irrigation at study site using gated pipe

Photo B. Vegetated and conventional ditches prior to runoff

Photo C. Vegetated and conventional ditches during runoff event
