Department of Pesticide Regulation

HSM-13012

SUBJECT: RESULTS FROM SAMPLING FOR PHOSGENE USING SALAD DEVICES
CHARGED WITH CHLOROPICRIN AND POSITIONED ON NON-
ABSORBENT SURFACE

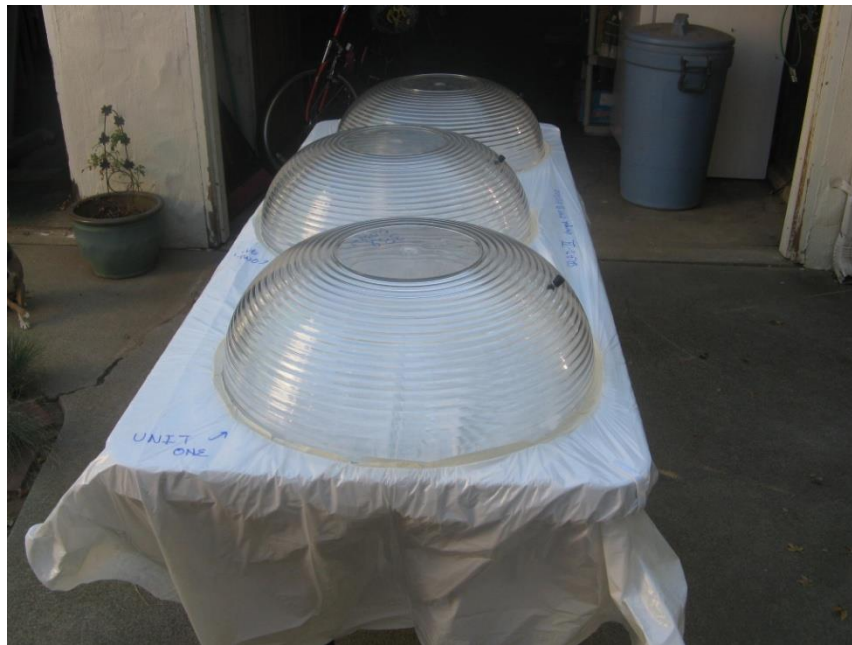
On August 5th, at 0745 hours, three SALAD units were charged with approximately 3 ± 1 microliters of PIC. Once again, the units were located such that they were in direct sun for about 6 hours per day (see Photo One).

Photo One: Deployed SALAD IV units

A temperature reading, taken at 1515 hours and using an infrared thermometer, indicated the three unit's temperature as 112° F (44° C). At 1910 hours, PIC samples were drawn from all three units. All three were at greater than 16 ppm, with no rebleaching effect.

Units One and Three showed close agreement in ratios of PIC to phosgene and close in absolute values. The lower values in Unit Two may be explained by the location of the unit on the table. Unit Two was situated over the folding seam of the table, which may have allowed gasses to permeate through the table covering and out into the general air.
