MEMORANDUM

HSM-15002

SUBJECT: RESULTS FROM CONSULTATION WITH TULARE CAC CONCERNING
VARIANCES FROM THE METHYL BROMIDE COMMODITY FUMIGATION
RECOMMENDATIONS AT A NUT PROCESSING PLANT

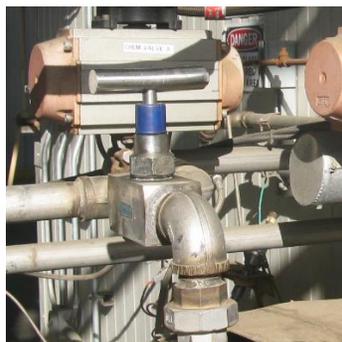
Photo One: Manual Valve

The failed valve was a manual control valve (Photo One) that can be used to isolate the upstream lines (including the automated valves) from the heat-exchanger.

Note that the photo shows the replacement valve and not the failed one which was switched out previous to my visit. During my consultation with the facility staff and the CAC, two issues concerning recommended commodity fumigation conditions were discovered. The most pressing issue was the proximity of one of the chambers to the control room (Photo Two). The control room is within the 10-foot buffer zone normally required for a vacuum chamber (see Reference Manual Methyl Bromide Commodity Fumigation [RefMan MBr], August 8, 1994, page 82: Summary of Buffer Zone Sizes). This places the control room in non-compliance with RefMan MBr. Since the access door to the control room also lies within the buffer zone of the chamber, it is not eligible for the “shear wall” exemption (i.e. no penetrations within the buffer zone). Additionally, the ventilation of the control room appears to be internally circulating, with no clean, outside air being introduced into the control room. This is a non-compliance with Condition 10: Control Room Ventilation (page 41, RefMan MBr)

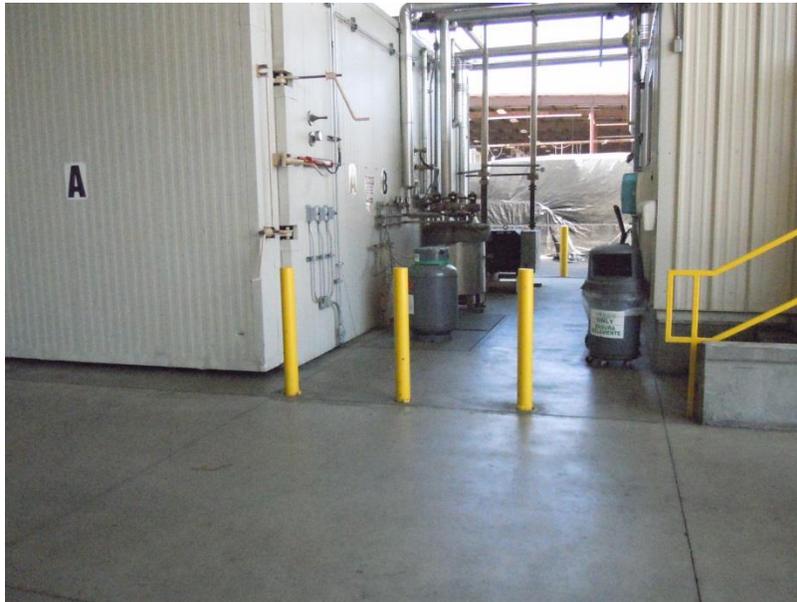
Photo Three: Fumigation equipment across from control room

Any subsequent fumigations done using methyl bromide in the south chamber will require use of self-contained breathing apparatus (SCBA) for persons working within the buffer zone, which includes the control room. The north chamber buffer zone does not extend to the control room and is therefore exempt from the SCBA requirement because of the buffer zone intrusion. However, because of the lack of fresh air ventilation (Condition 10), and proximity to the fumigation equipment and the north chamber (See Photo Three), SCBA would also be required when methyl bromide is used for this chamber too (Condition 10: Possible Alternative Conditions, page 41 RefMan MBr).

Because of the physical construction of the south chamber and the control room, relocation of either structure is not realistically possible. One potential solution that would alleviate the need for SCBA, at least during the fumigation cycle, would be the installation of a real-time constant-monitoring system, such PureAire (<http://www.pureairemonitoring.com>) or Series 8900 GC (<http://www.baseline-mocon.com/>) or Uniphos 251PM (<http://ionscienceusa.com/>) or TA-2100 Methyl Bromide Gas Detector (<http://www.mil-ram.com/>). Note that citation of these devices and manufactures is not to be considered an endorsement or approval of such devices and manufacturers. Any system capable of real-time monitoring of methyl bromide to a minimum detection level of 3 ppm would be adequate.
